# Report

Prepared for RPS Planning & Development

In connection with Structural Survey of 4 Nr Reema Flat Blocks in Milton Keynes

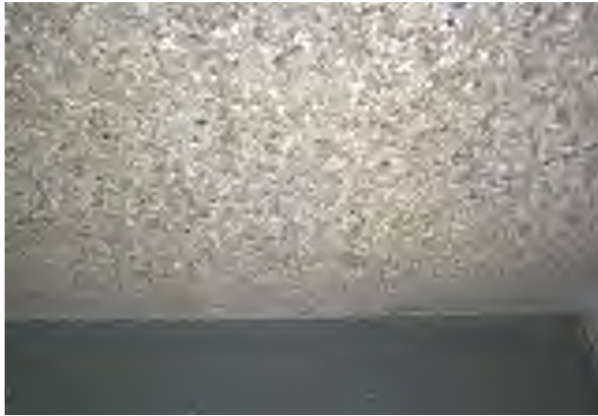
#### Photograph 4:

Defect Type 1 - Cracking observed to panel joints in communal staircase area.

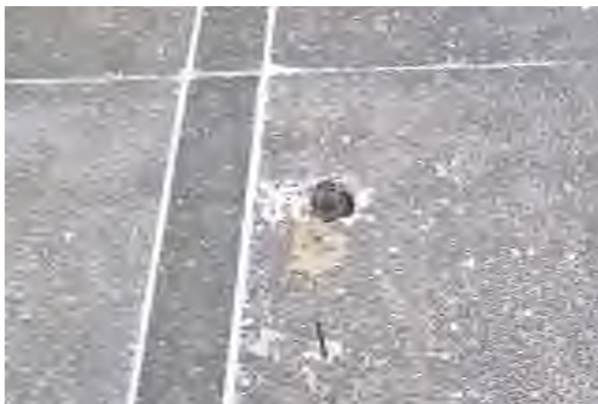
#### Photograph 7:

Defect Type H - Spalling to PRC front door canopy observed, showing steel reinforcement visible and corroding.

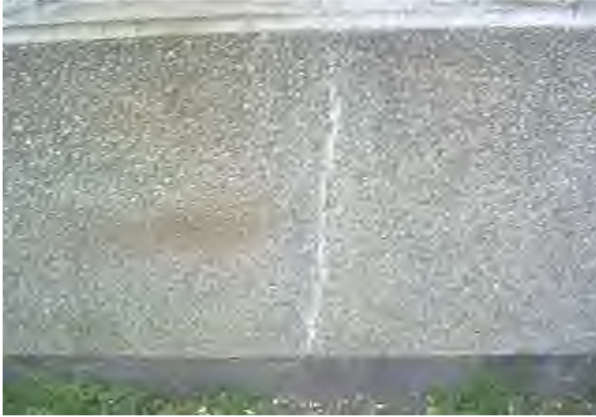
#### Photograph 8:

Defect Type M - Damaged PRC panel observed at previously installed boiler flue.

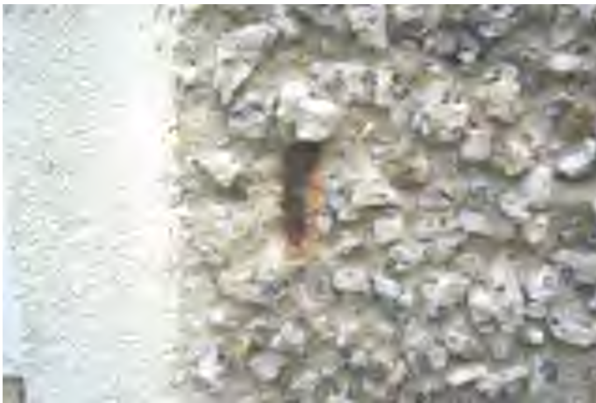
#### Photograph 9:

Defect Type A - Cracking observed to PRC panel externally.

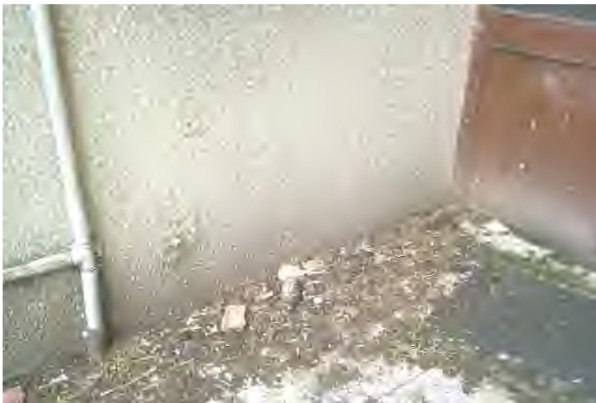
#### Photograph 10:

Defect Type B – Spalling observed to PRC panel.

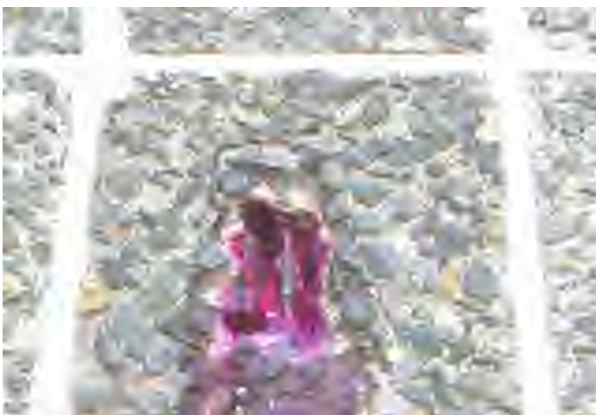
#### Photograph 11:

Defect Type C - Staining observed to PRC panels.

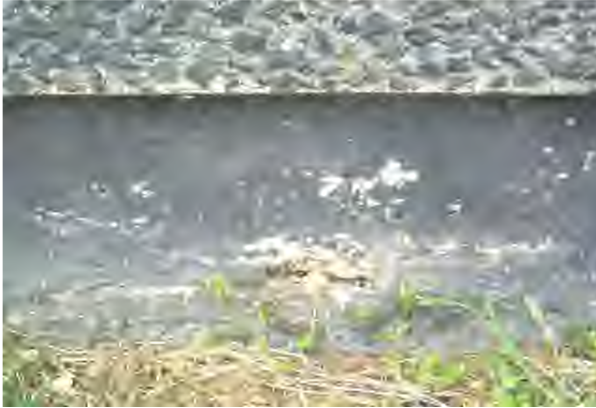
#### Photograph 12:

Carbonation test to PRC panel showing minimal carbonation present and steel reinforcement to be in satisfactory condition.

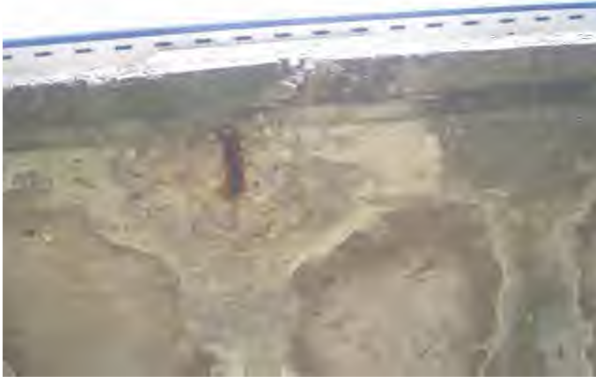
**Photograph 16:**

Defect Type 1 - Cracking observed to panel joints in communal staircase area.

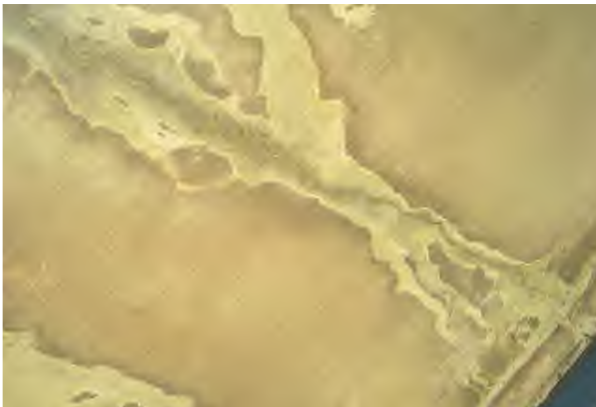
**Photograph 17:**

Defect Type H - Spalling observed to PRC front door canopy.

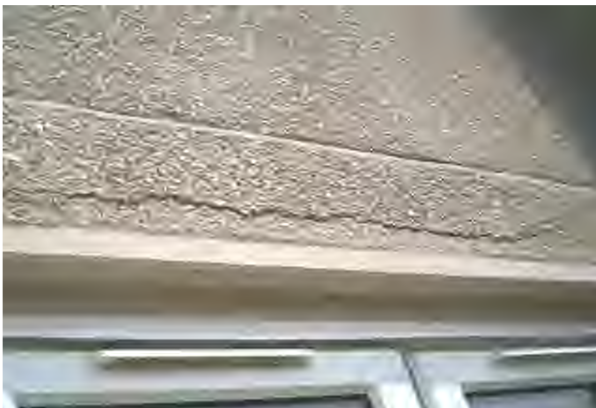
**Photograph 18:**

Defect Type G - Cracking observed to PRC front door canopy.

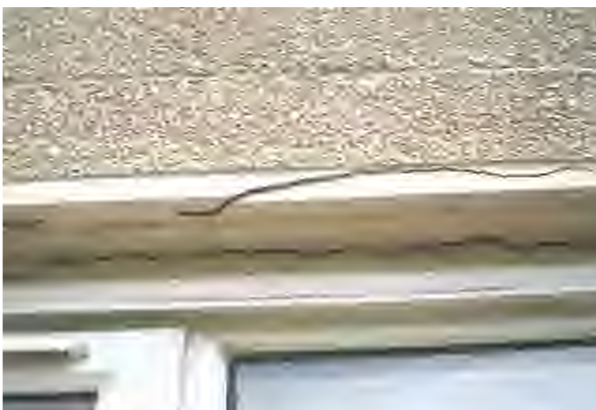
**Photograph 19:**

Defect Type A - Cracking observed to external PRC panel.

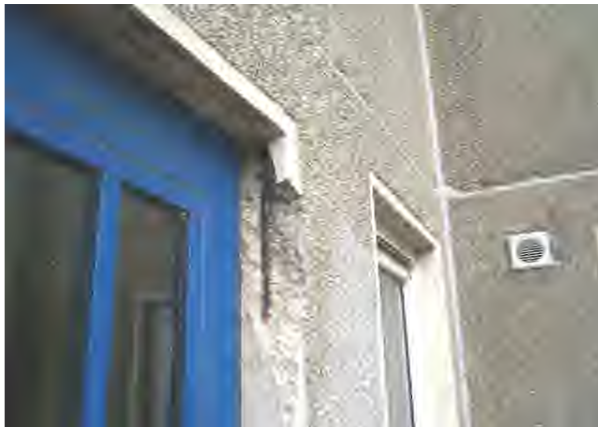
**Photograph 21:**

Defect Type N - Cracking observed to external PRC panel at door reveal.

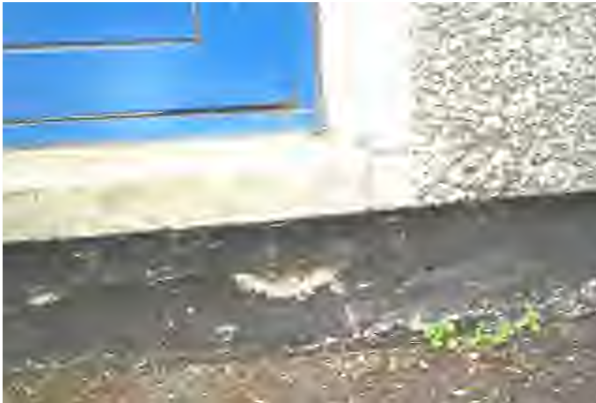
**Photograph 24:**

Defect Type C - Staining observed to external PRC panels.

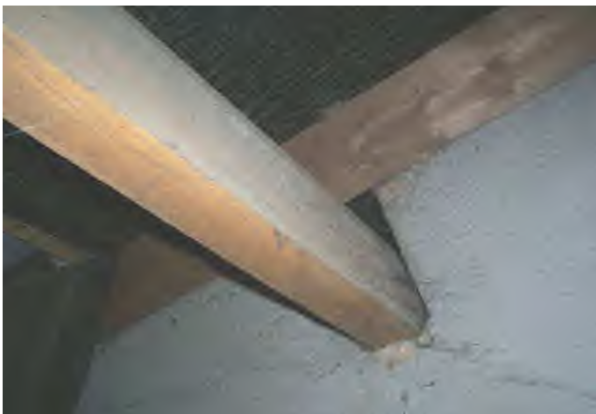
#### Photograph 26:

Typical roof construction showing traditional sawn timber rafters and purlins to be in satisfactory condition.

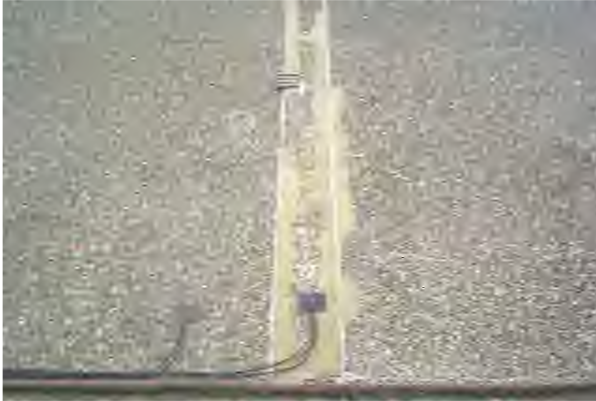
#### Photograph 32:

Defect Type A - Cracking observed to dividing panel on gable elevations.

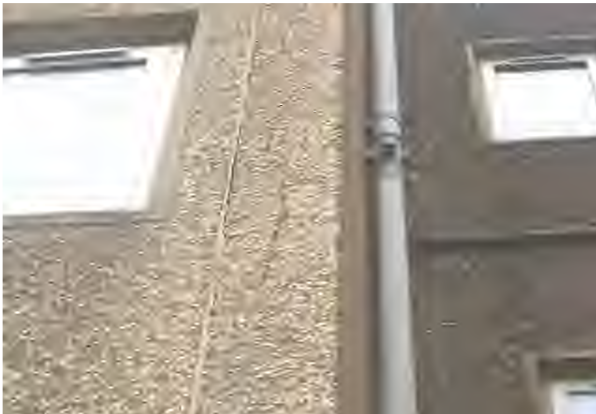
**Photograph 33:**

Defect Type R - Previous patch repairs observed to dividing panel on gable elevations.

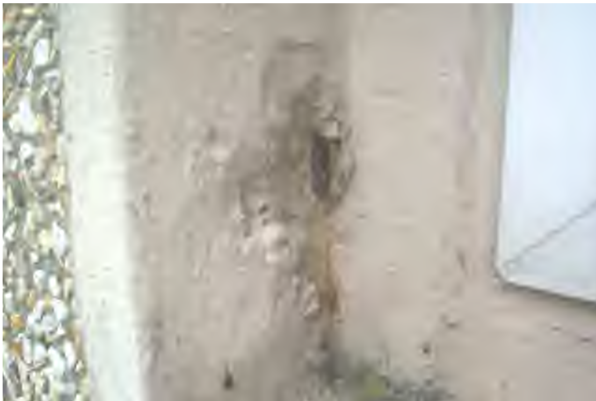
**Photograph 34:**

Defect Type A - Cracking observed to external PRC panel.

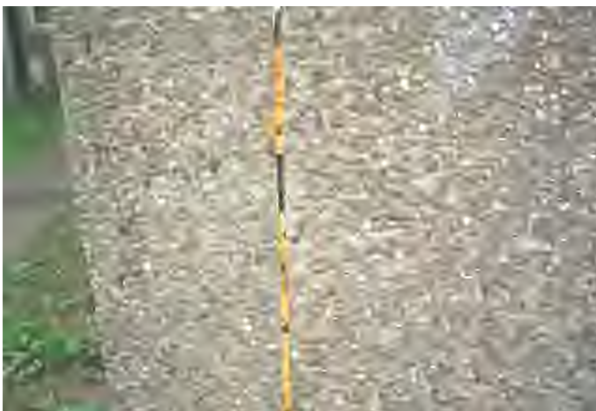
**Photograph 35:**

Defect Type B - Spalling observed to external PRC panel.

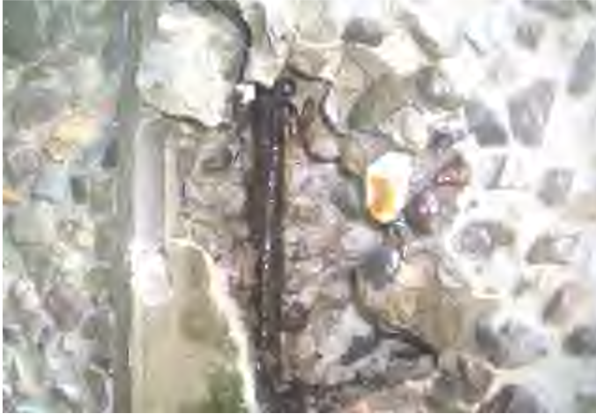
**Photograph 36:**

Defect Type D - Mortar / mastic observed missing from panel joints.

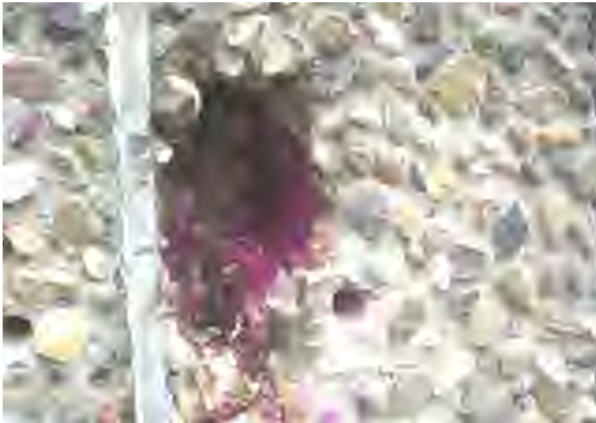
**Photograph 37:**

Carbonation test showing PRC panel to be fully carbonated and steel reinforcement to be corroding.

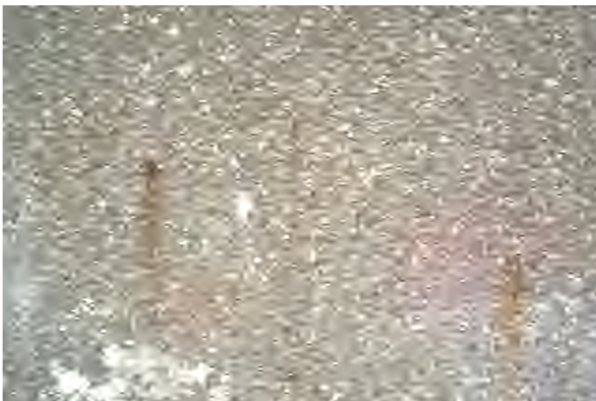
**Photograph 38:**

Carbonation test to PRC panel showing minimal carbonation present and steel reinforcement to be corroding.

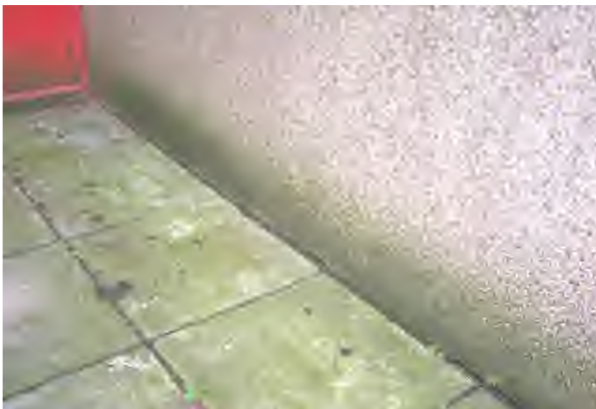
**Photograph 39:**

Areas of previous patch repairs and staining of concrete cladding panels was noted at the majority of blocks inspected. Minor rust spotting to the PRC panels was also noted at Stirling House.

Defect Type Q - Rust spotting visible to external PRC panels.

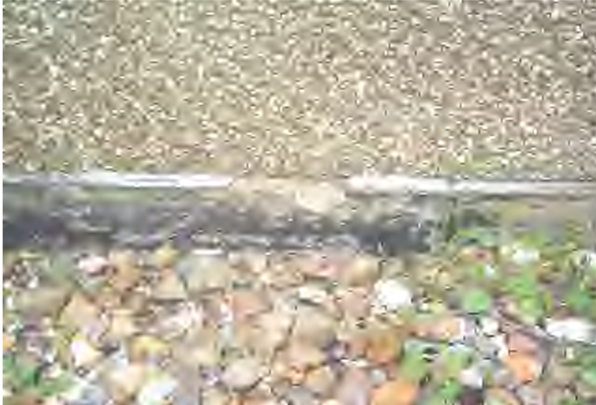
**Photograph 40:**

Defect Type C - Staining observed to external PRC panels.

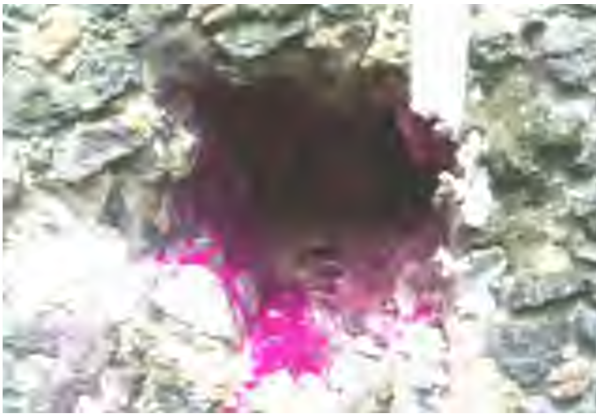
**Photograph 49:**

Defect Type O – Spalling observed to PRC door reveal.

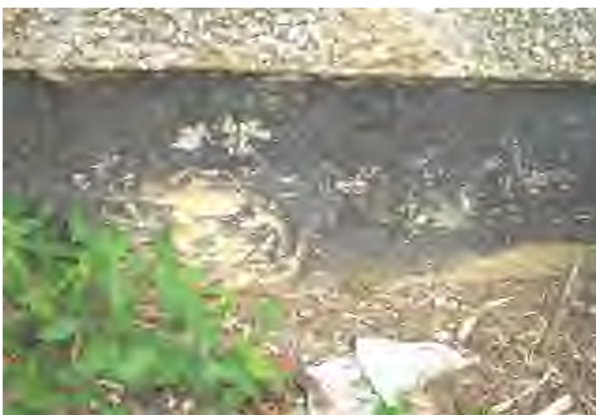
**Photograph 51:**

Defect Type C – Staining observed to PRC panels.
